HRS DOCUMENTATION RECORD – REVIEW COVER SHEET

Name of Site: Grain Handling Facility at Freeman

HRS DOCUMENTATION RECORD

Date Prepared: March 2015

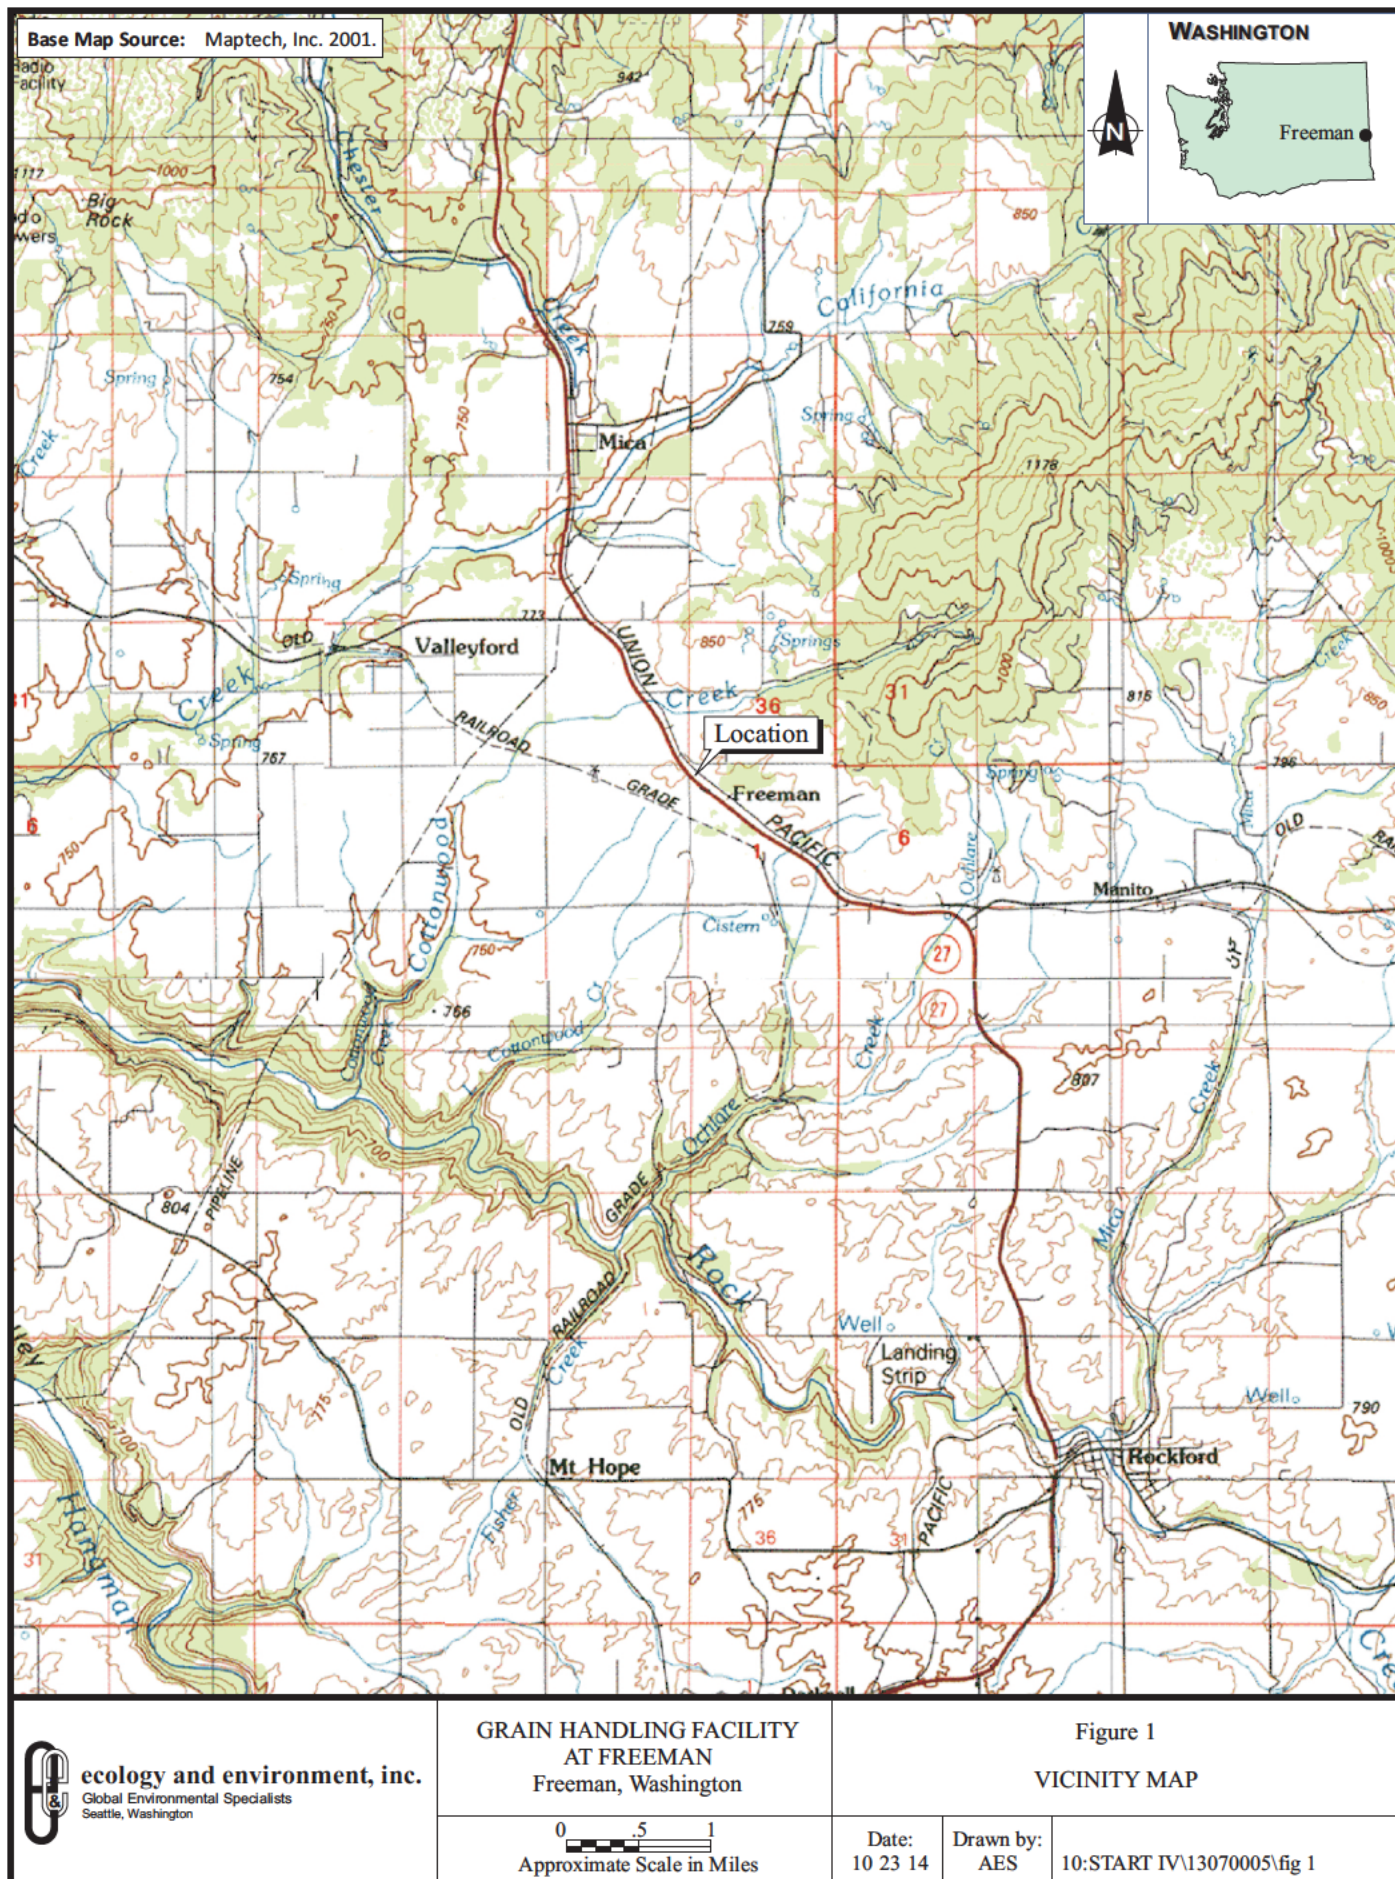
Base Map Source: Google Earth Pro 2013.
 Notes: Feature Labels from Ref. 4, p. 62 (Figure 2 2) and 65 (Figure 3 2).

The source scored for this HRS documentation record is subsurface contaminated soil at the Grain Handling Facility at Freeman (Source 1) (Figure 1). Analytical results indicate the presence of the hazardous substances carbon tetrachloride and chloroform in subsurface soil samples from the Grain Handling Facility at Freeman (see Section 2.2.2 of this documentation record, Table 1). An observed release of these hazardous substances to the drinking water aquifer has been confirmed (see Section 4.1.2.1.1 of this documentation record, Tables 5 through 8). In relation to targets in the ground water migration pathway, it has been documented that the Freeman School District's Primary drinking water supply well, located downgradient of the contaminated soil source, is subject to actual contamination (see Section 3.3 of this documentation record) (Figure 2 and Ref. 12, pp. 14 and 36 [Figure 8]).

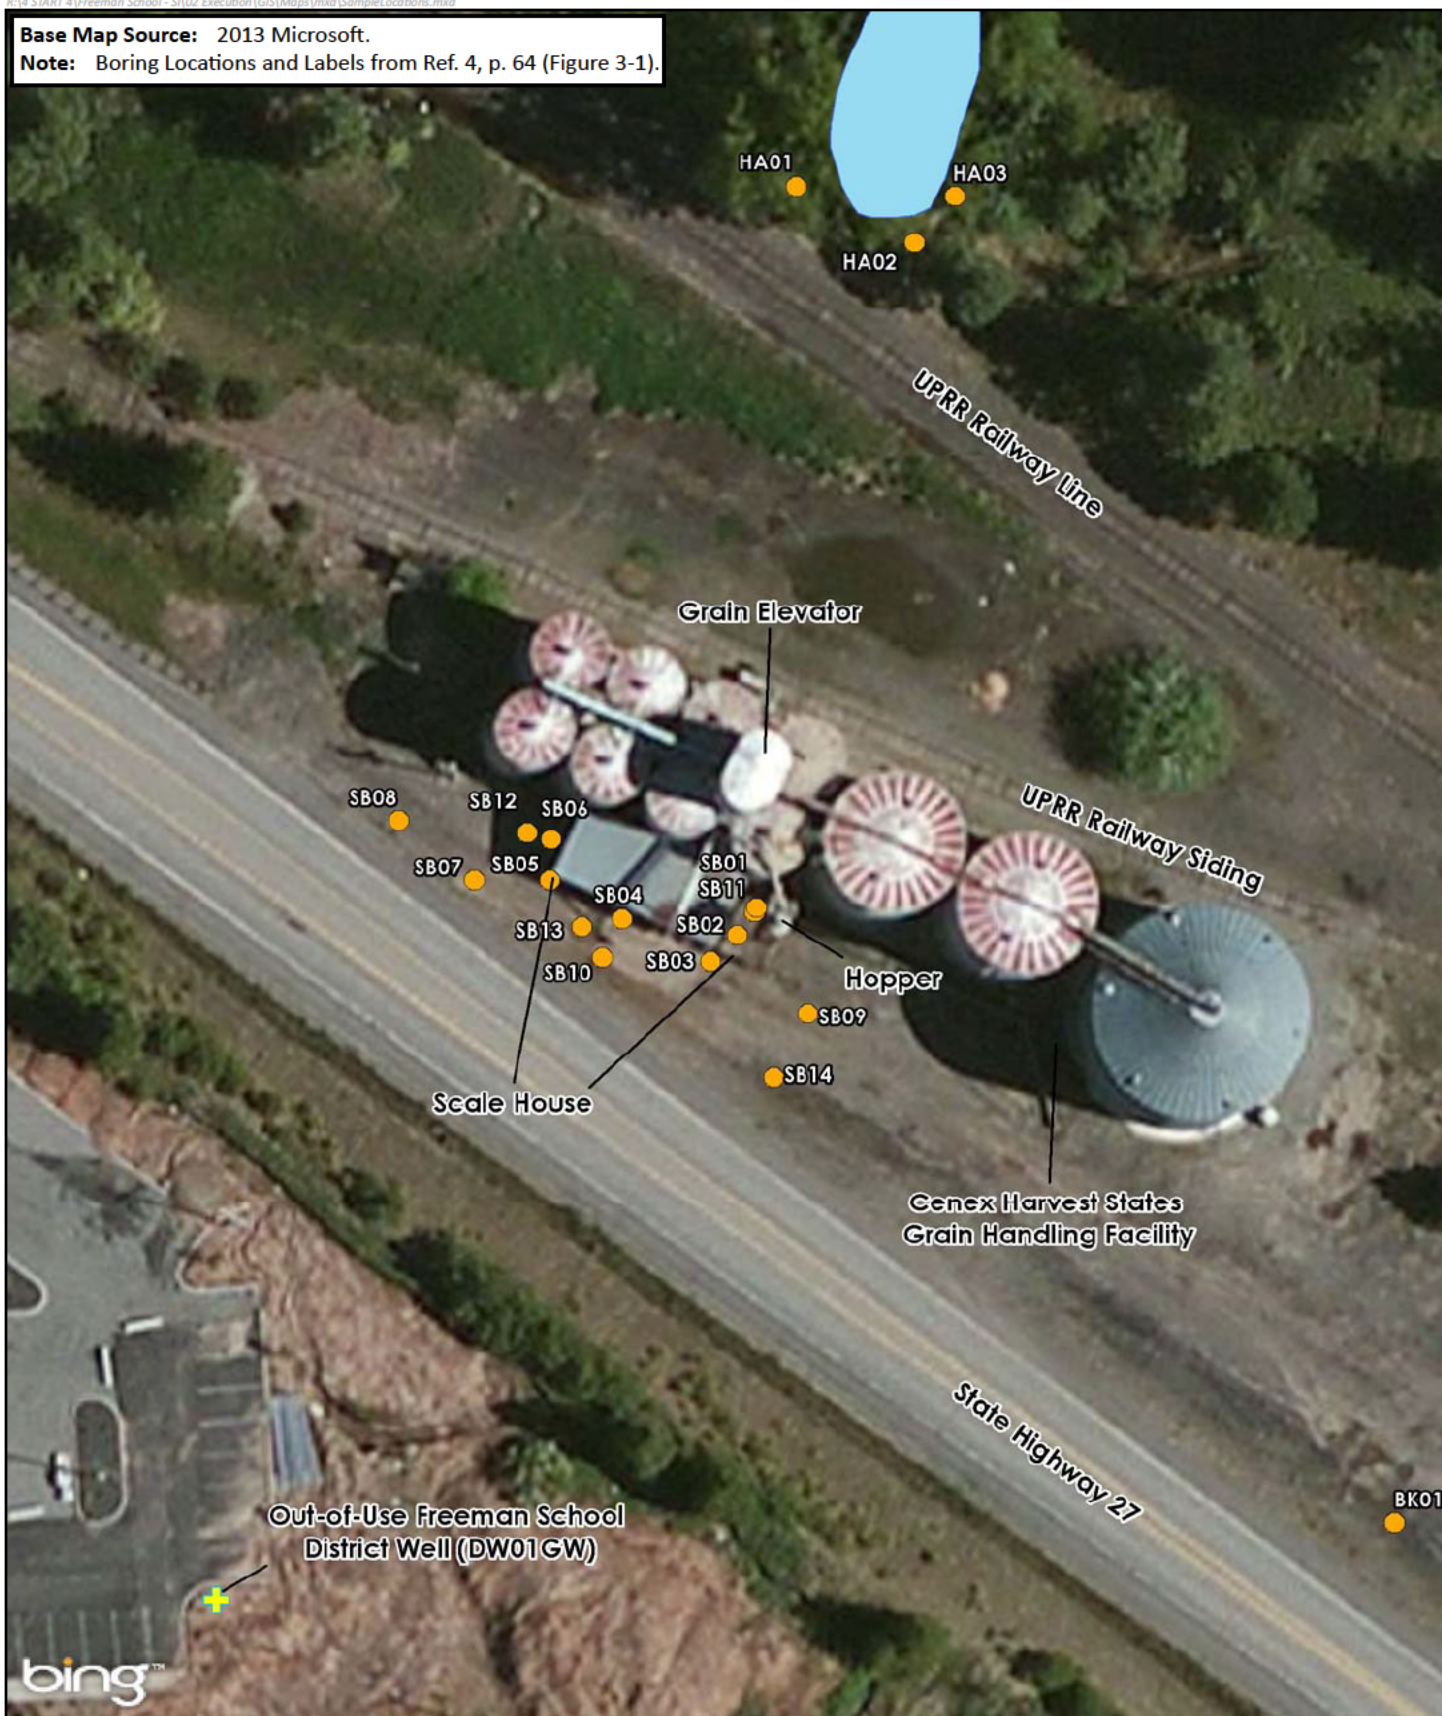
Note: Boring Locations and Labels from Ref. 4, p. 64 (Figure 3-1).

- Well
- Soil Boring
- Pond

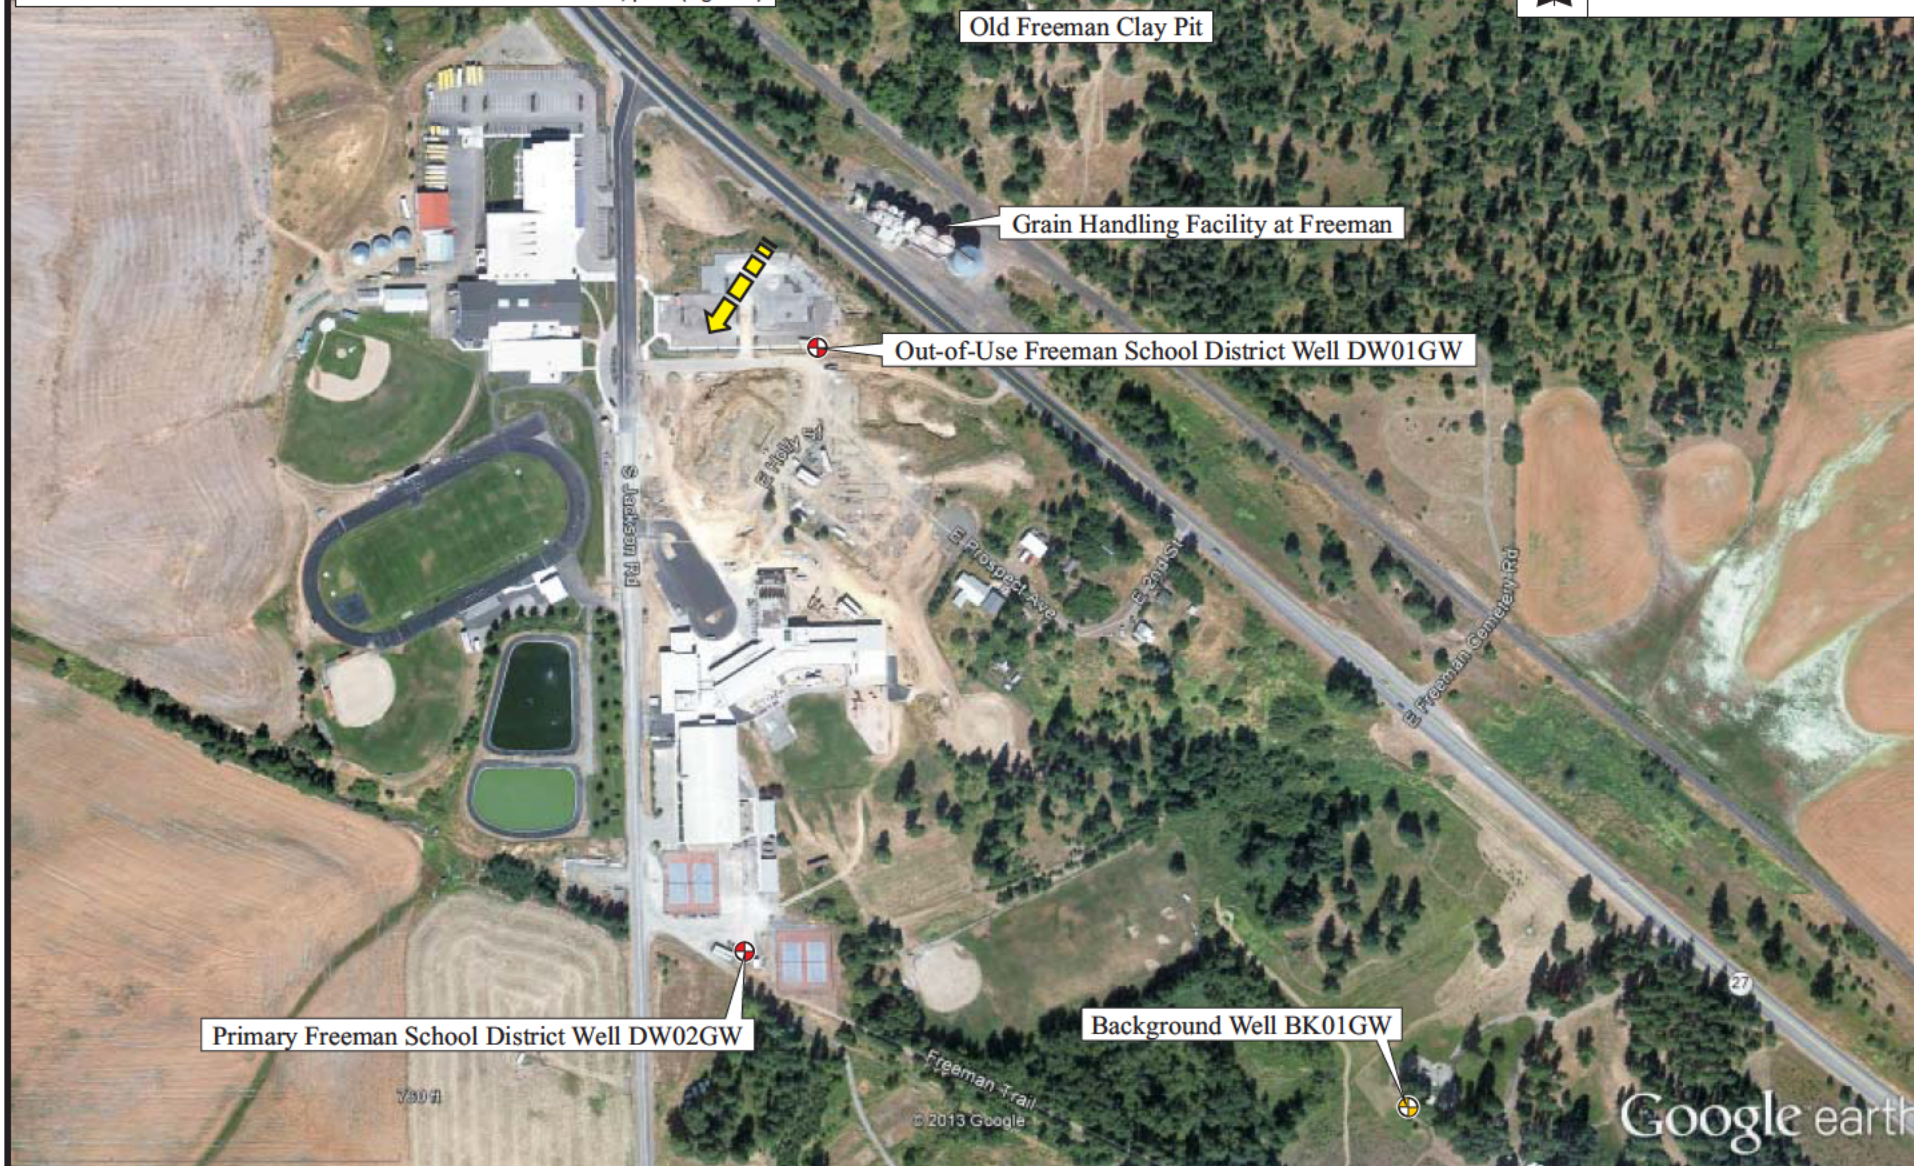
Key:

Approximate Interpreted Groundwater Flow Direction

This source is hydrogeologically upgradient of the Freeman School District out-of-use well given that ground water generally flows from northeast toward southwest (Figure 2 and Ref. 12, p. 14). It should be noted, that when carbon tetrachloride enters the ground water, this chemical will migrate downward until it encounters a geologic barrier that prevents further vertical movement (Ref. 17, p. 2). At this point, the chemical will continue to break down at a slow rate and may persist in various constituent forms for many years, decades, or longer (Ref. 17, p. 2). The hazardous substances detected at observed release concentrations in ground water are the same as those detected in the Source 1 samples (see Section 2.2, Source 1 and Section 4.1.2.1.1, Observed Release).
